NASA Engineering and Safety Center Technical Consultation Report	Document #: RP-06-115	Version: 1.0
Title: ISS S-Band Corona Discharge Anomaly Consultation			Page #: 1 of 26

International Space Station (ISS) S-Band Corona Discharge Anomaly

December 14, 2006

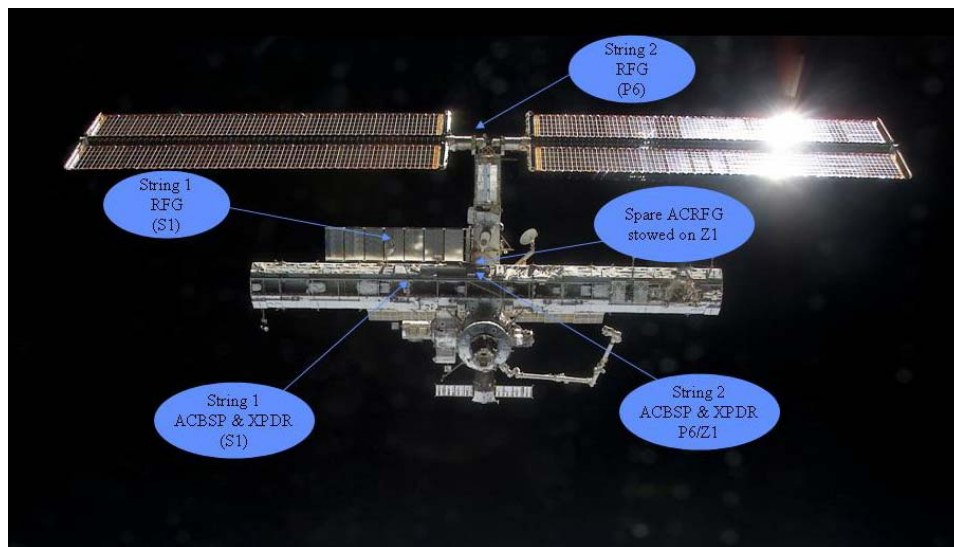
Figure 6.1-2. ISS S-Band Installation Sites

On April 13, 2006, there was a reflected RF power anomaly observed after four minutes nominal operation within the ACRFG (refer to Figure 6.1-1). This was in the “String 1 RFG” unit on S1 (S/N 002) as shown on the ISS in Figure 6.1-2. The “String 2 RFG” unit (S/N 003) on P6 is the primary unit. The spare unit (S/N 001) is stowed on Z1. Corona was examined as a possible root cause of the anomaly. Section 3.5 of the MDA ACRFG Reflected RF Power Anomaly Report (ref. 1) determined the necessary voltages to produce corona, at various pressures, in the narrowest electrode gaps in the coaxial cavity 5-pole diplexer and 3-pole bandpass filter (see Figure 6.1-3) assemblies. The results of the MDA analysis suggest the conditions present in the Bandpass Filter and Diplexer at 1 psia may have been favorable for the corona.
